WIMBLEDON SCHOOL OF ART FOYER
Ground Floor Plan - PROPOSED

335/17-C3

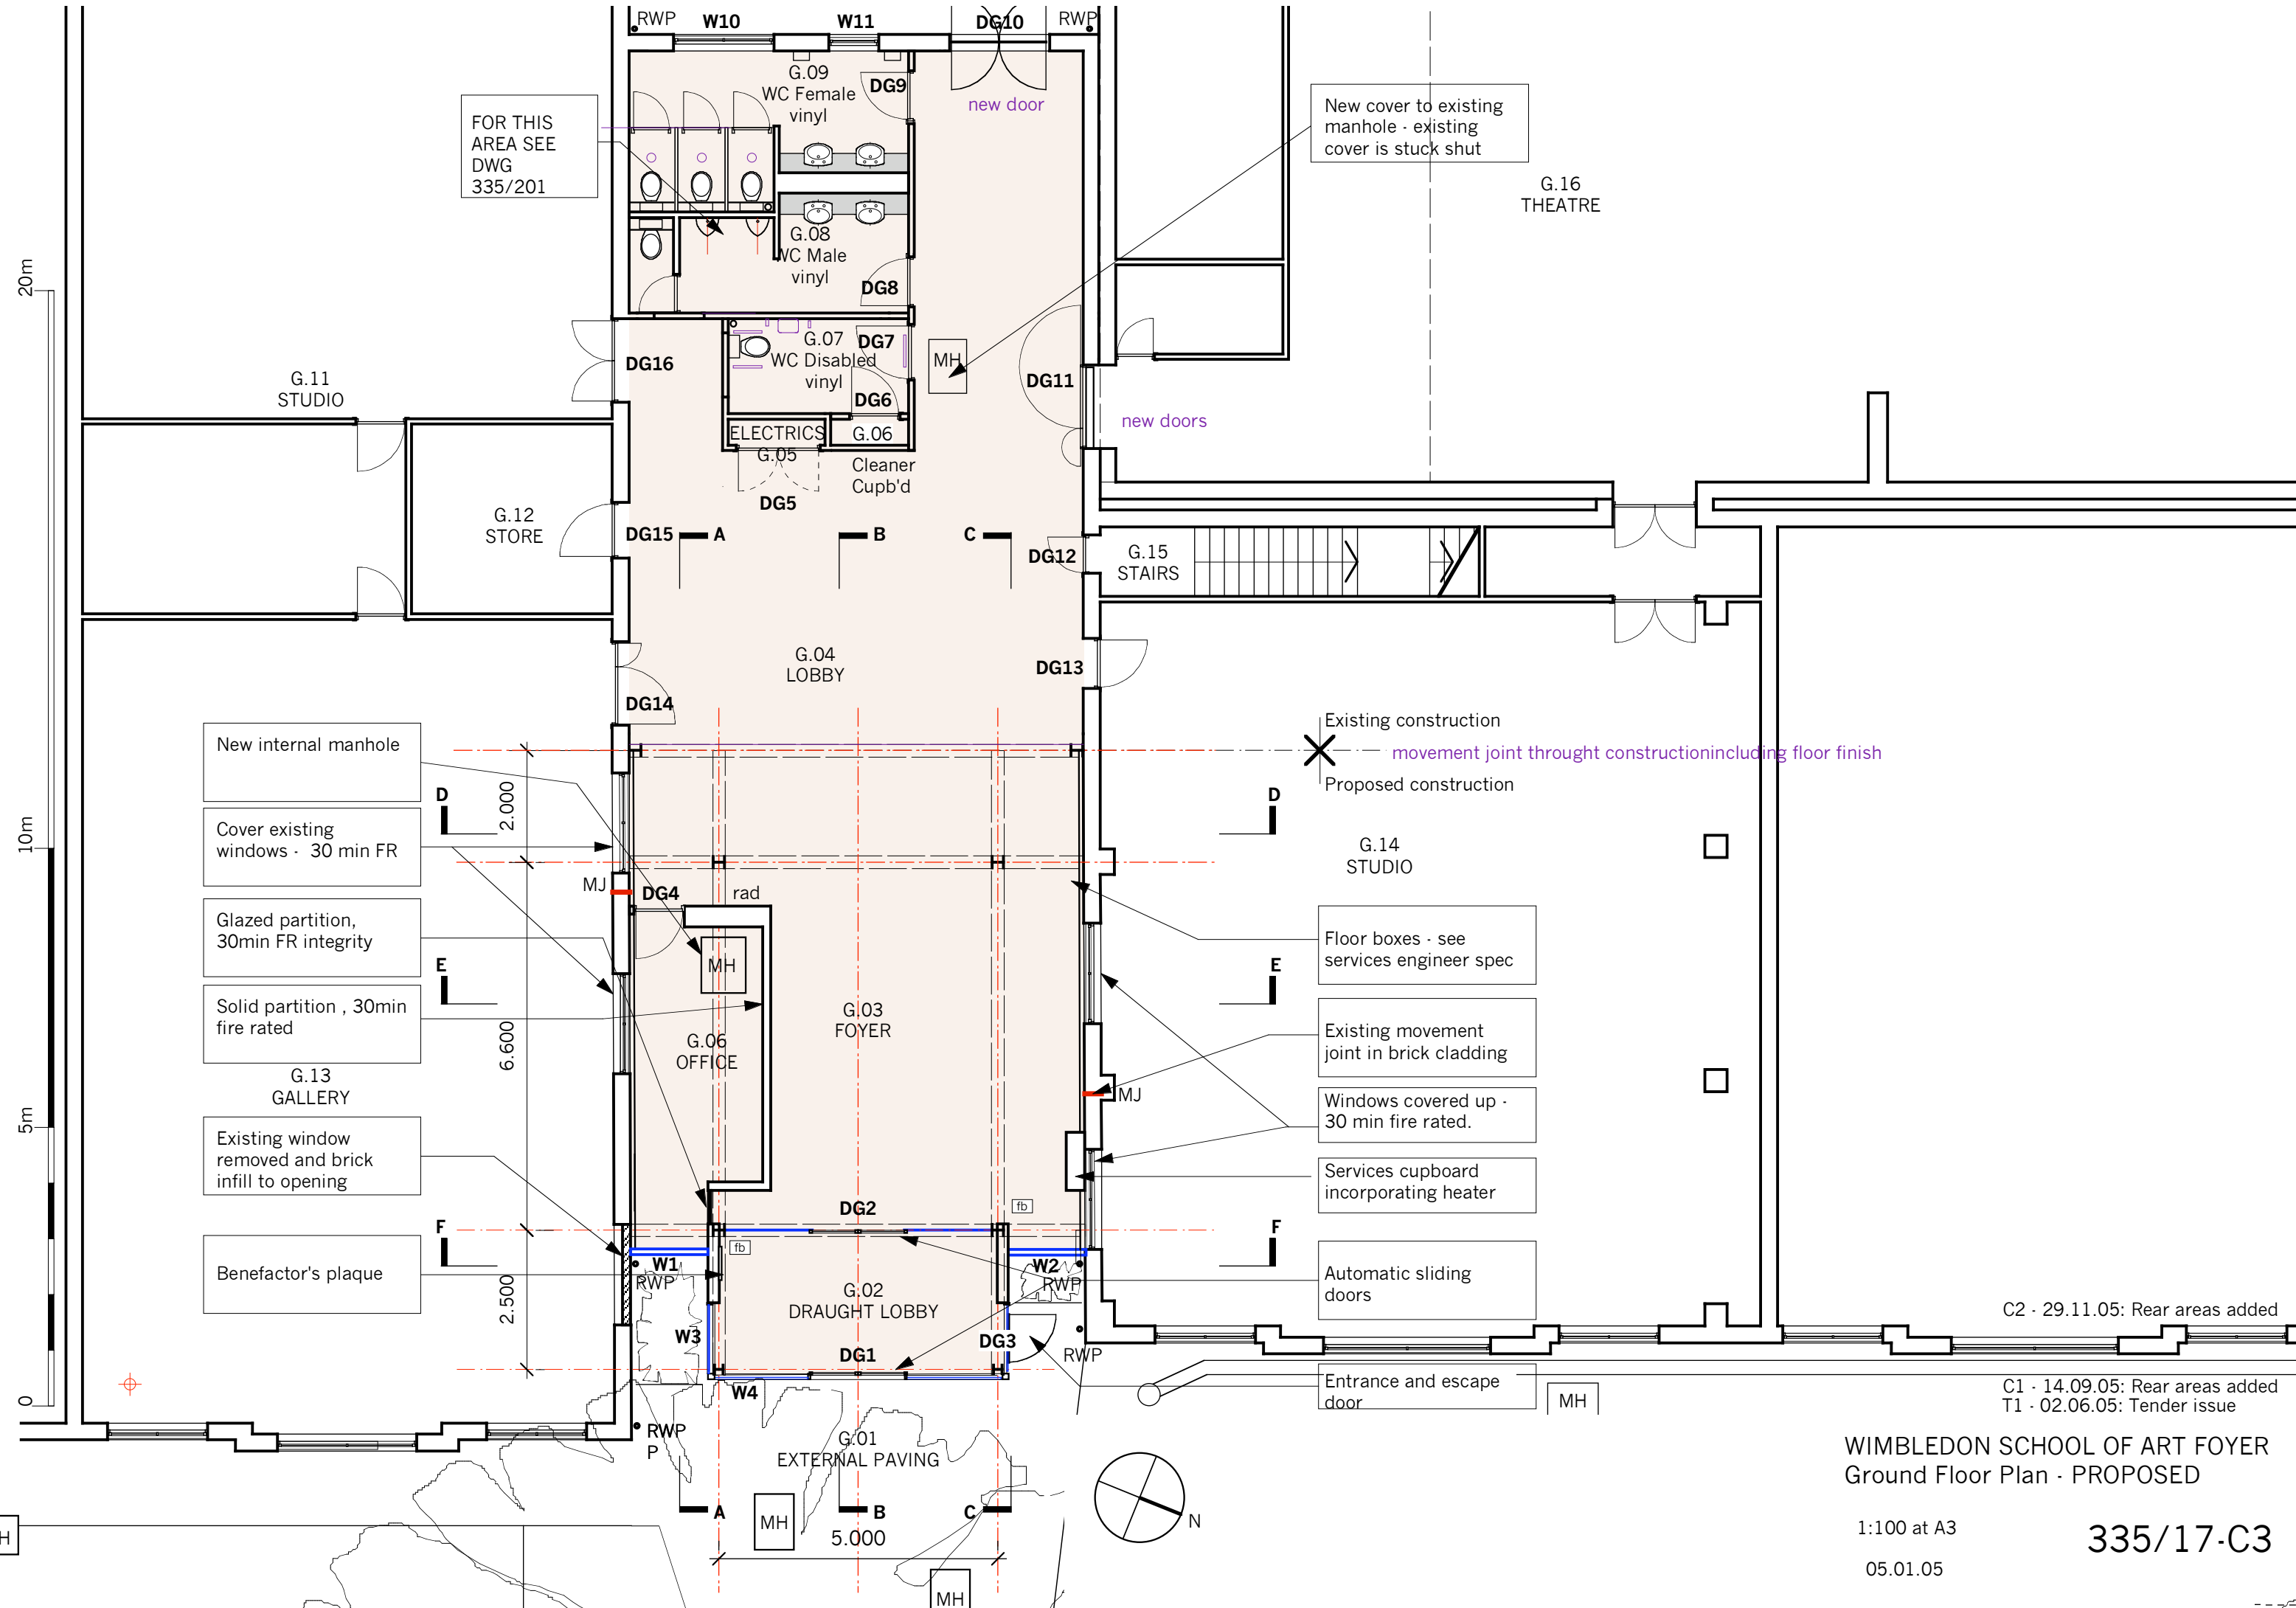
New cover to existing manhole - existing cover is stuck shut

- New internal manhole
- Cover existing windows - 30 min FR
- Glazed partition, 30min FR integrity
- Solid partition, 30min fire rated
- G.13 GALLERY
- Existing window removed and brick infill to opening
- Benefactor's plaque

- Existing construction
- Proposed construction
- G.14 STUDIO
- Floor boxes - see services engineer spec
- Existing movement joint in brick cladding
- Windows covered up - 30 min fire rated.
- Services cupboard incorporating heater
- Automatic sliding doors
